Inspection Report

Property Address:
758 Haverhill Drive
Sunnyvale CA 94087

Anderson Home Inspector LLC

Date: 7/20/2010	Time: 02:00 PM	Report ID: 072010HASU
Property: 758 Haverhill Drive Sunnyvale CA 94087	Customer: Sungho Park	Real Estate Professional: Jenny Huh US Network Realty

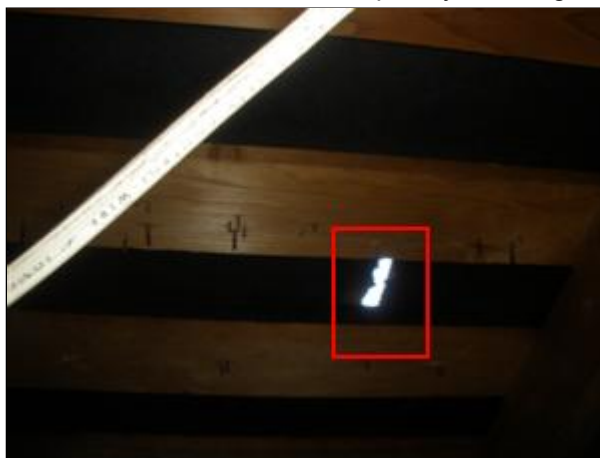
1.0 Picture 1 Roof hole above living room)

The roof appeared to have signs of wearing and minor leaking. Some roof shakes were noted missing on areas of the roof. Observing from inside the attic, some holes were found under the roof felt when the sun light shined through the holes (see example in picture 1). Observing from inside the attic above the hallway, some minor water stains were also noted under the roof ridge . Recommend further evaluation and repair by a roofing contractor.

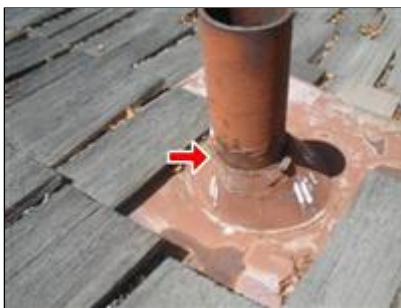
1.2 Picture 1

A roof plumbing vent jack on the left has worn sealant (Picture 1). Recommend re-sealing or installing the rubber boot to prevent water intrusion.

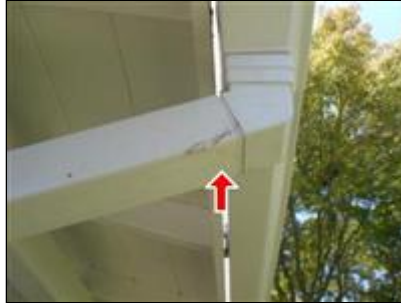
1.3 Picture 1

The front left gutter downspout is loose. Recommend the downspout to be secured for improvement (Picture 1). There are leaves and debris on areas of the roof gutters. Recommend cleaning the rain gutters and monitoring for clogs during rainy seasons.

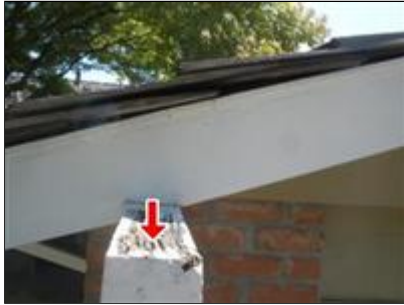
2.4 Picture 1 (Front decorative beam)

There appear to be fungus damages on areas of the exterior wood members (See examples in picture 1, 2, 3, 4 & 5). Recommend further evaluation and repair by a termite inspector.

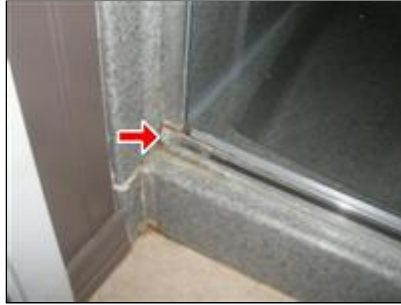
4.7 Picture 1

There is inadequate caulking at the lower left corner of the shower stall which allows water leaking to the outside of the shower stall (Picture 1). Recommend re-caulking as needed for improvement.

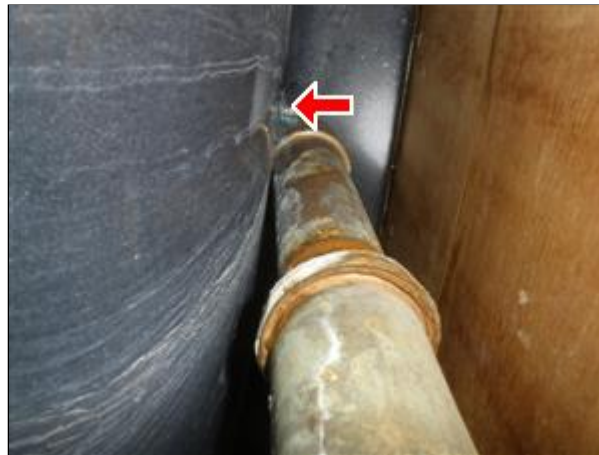
6.0 Picture 1

A leak is found at the bathtub drain connection under the hall bathroom (Picture 1). Recommend further evaluation and repair by a licensed plumber.

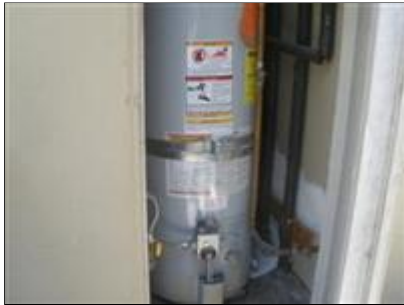
6.2 Picture 1

The water heater appears to be in good condition (Picture 1). It is secured with 2 seismic straps to resist falling and lateral movement.

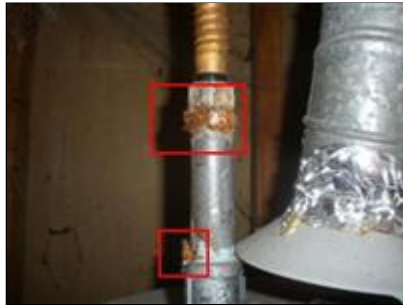
6.2 Picture 2

The water pipe connection above the water heater is noted to be corroded and susceptible to leaking (Picture 2). Recommend the corroded pipe component to be replaced by a qualified plumber.

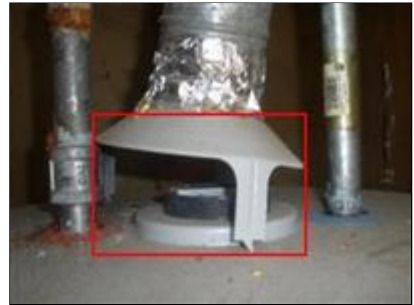
6.2 Picture 3

The draft diverter above the water heater is not properly attached (Picture 3). Recommend draft diverter to be properly installed by a qualified plumber.

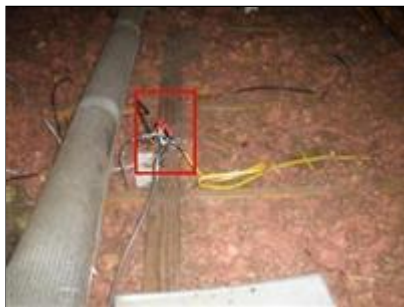
7.2 Picture 1

A wiring in the attic was noted to be not neatly installed, and the splices are not properly installed inside the junction box as required (Picture 1). Recommend further evaluation and improvement by a qualified electrician.

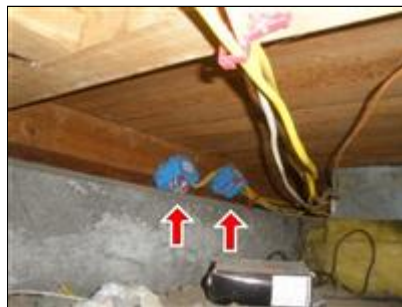
7.2 Picture 2

Two junction boxes was noted missing the cover plates as view from the crawl space below the living room area (Picture 2). Recommend the cover plates to be replaced by an electrician for electrical safety improvement.

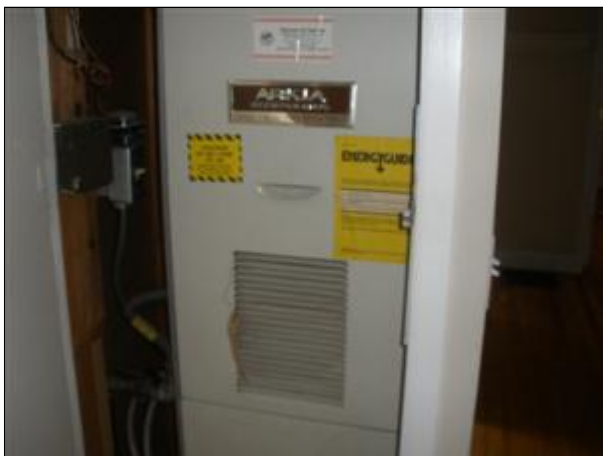
8.0 Picture 1

The gas furnace appeared to be in good condition (Picture 1). It appeared functional and responded to the thermostat control.

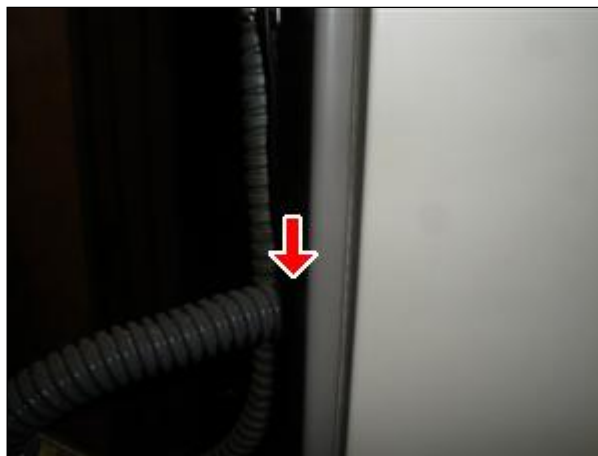
8.0 Picture 2

A flexible gas feed line has been routed through the furnace cabinet (Picture 2). This is commonly seen in older installations. This condition is vulnerable to damage by the sharp edges of the sheet metal; therefore, it is considered unsafe by current standard. A solid gas pipe should be installed through the furnace cabinet for improvement. Another option is to use a shroud to cover around the flexible gas feed line to protect it from damage by the cabinet. Recommend further evaluation and improvement by a heating specialist.

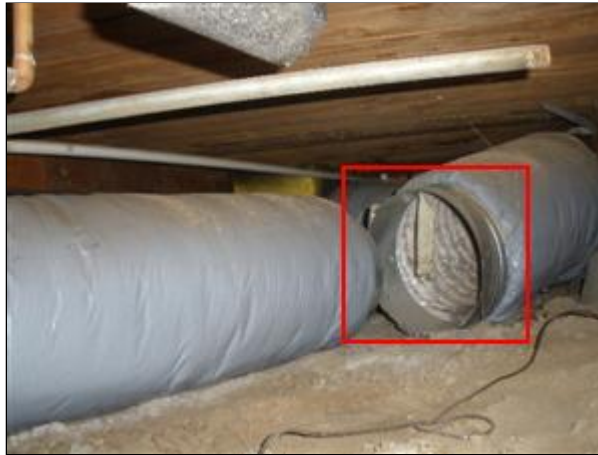
8.2 Picture 1

Observing from inside the crawl space, the return-air duct was noted to be disconnected below the hallway area (Picture 1). Recommend further evaluation and repair by a heating contractor.

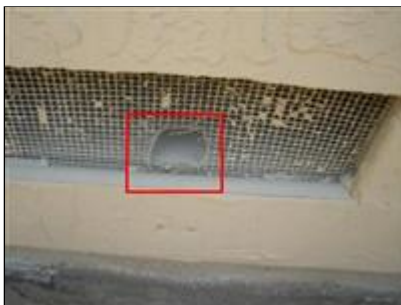
9.2 Picture 1

A left exterior wall screen was noted to be broken (Picture 1). Recommend the vent screens to be repaired or replaced to prevent vermins from entering the house.

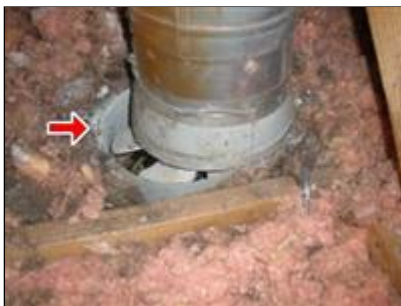
9.3 Picture 1

The exhaust vent in the hall bathroom is not properly secured above the ceiling. It leaks exhaust air and moisture into the attic (Picture 1). Recommend further evaluation and repair by a licensed contractor.

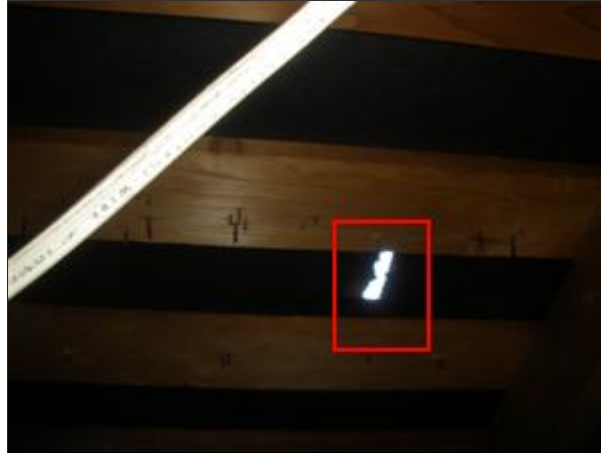
Item 1 - Picture 1 Roof hole above living room)

The roof appeared to have signs of wearing and minor leaking. Some roof shakes were noted missing on areas of the roof. Observing from inside the attic, some holes were found under the roof felt when the sun light shined through the holes (see example in picture 1). Observing from inside the attic above the hallway, some minor water stains were also noted under the roof ridge . Recommend further evaluation and repair by a roofing contractor.

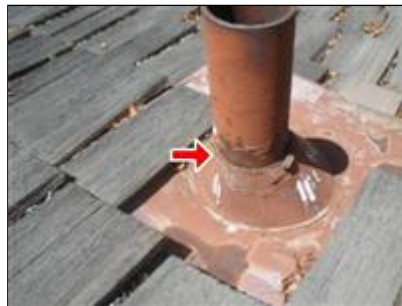
Item 2 - Picture 1

A roof plumbing vent jack on the left has worn sealant (Picture 1). Recommend re-sealing or installing the rubber boot to prevent water intrusion.

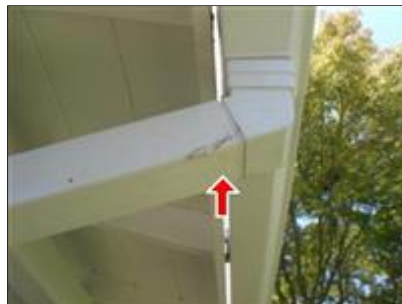
Item 3 - Picture 1

The front left gutter downspout is loose. Recommend the downspout to be secured for improvement (Picture 1). There are leaves and debris on areas of the roof gutters. Recommend cleaning the rain gutters and monitoring for clogs during rainy seasons.

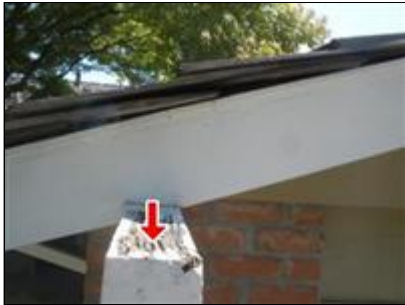
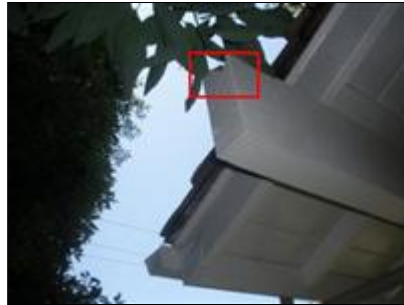
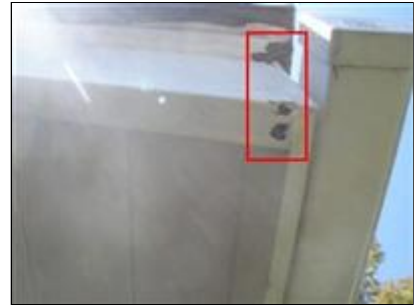
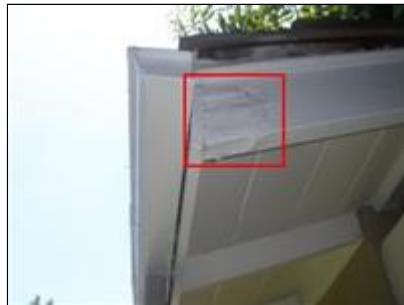
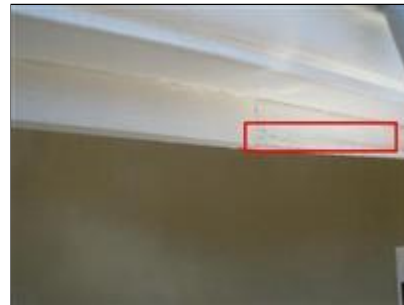
There appear to be fungus damages on areas of the exterior wood members (See examples in picture 1, 2, 3, 4 & 5). Recommend further evaluation and repair by a termite inspector.

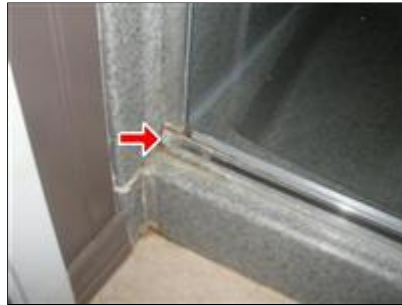
Item 8 - Picture 1

There is inadequate caulking at the lower left corner of the shower stall which allows water leaking to the outside of the shower stall (Picture 1). Recommend re-caulking as needed for improvement.

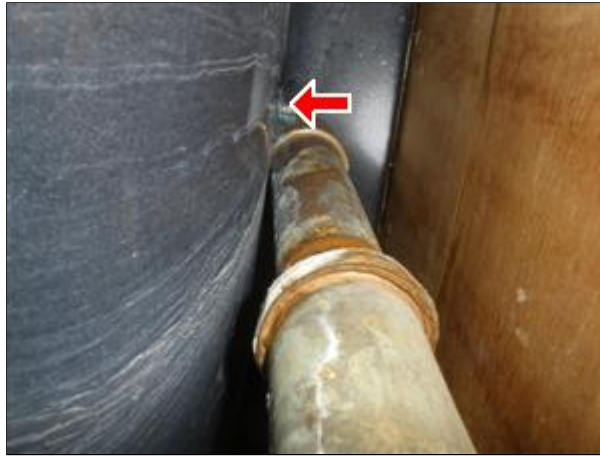
Item 9 - Picture 1

A leak is found at the bathtub drain connection under the hall bathroom (Picture 1). Recommend further evaluation and repair by a licensed plumber.

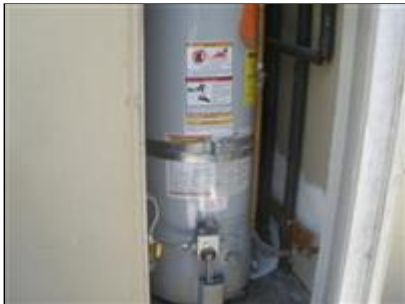
Item 10 - Picture 1

The water heater appears to be in good condition (Picture 1). It is secured with 2 seismic straps to resist falling and lateral movement.

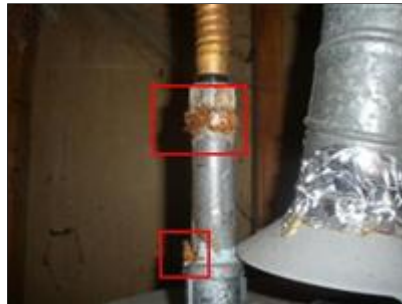
Item 10 - Picture 2

The water pipe connection above the water heater is noted to be corroded and susceptible to leaking (Picture 2). Recommend the corroded pipe component to be replaced by a qualified plumber.

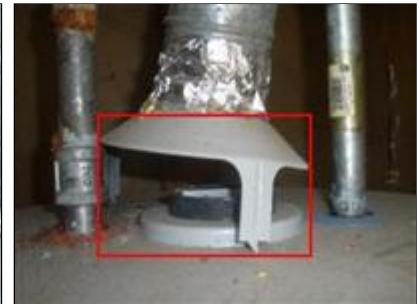
Item 10 - Picture 3

The draft diverter above the water heater is not properly attached (Picture 3). Recommend draft diverter to be properly installed by a qualified plumber.

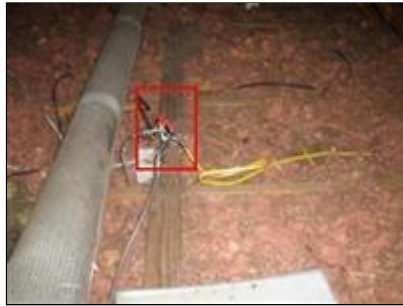
Item 11 - Picture 1

A wiring in the attic was noted to be not neatly installed, and the splices are not properly installed inside the junction box as required (Picture 1). Recommend further evaluation and improvement by a qualified electrician.

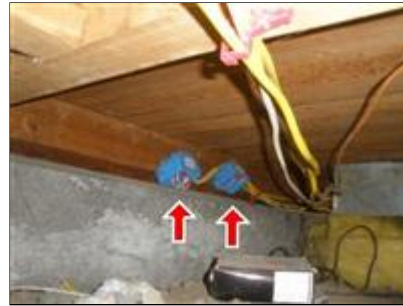
Item 11 - Picture 2

Two junction boxes was noted missing the cover plates as view from the crawl space below the living room area (Picture 2). Recommend the cover plates to be replaced by an electrician for electrical safety improvement.

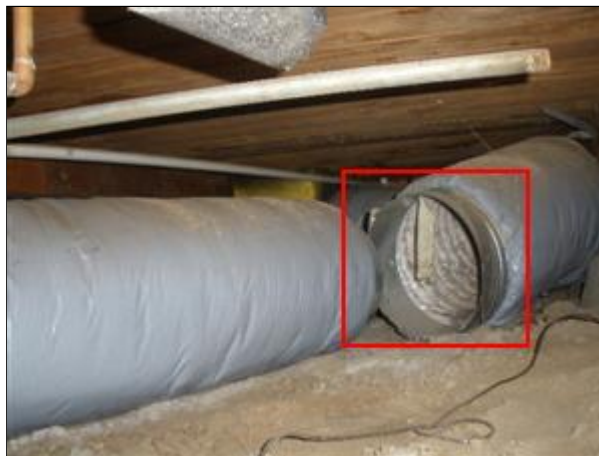
Item 12 - Picture 1

Observing from inside the crawl space, the return-air duct was noted to be disconnected below the hallway area (Picture 1). Recommend further evaluation and repair by a heating contractor.

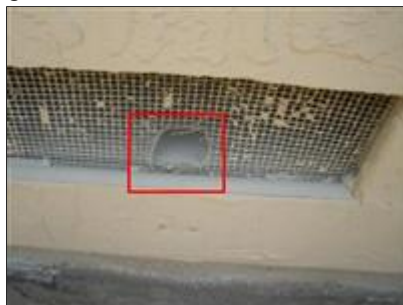
Item 13 - Picture 1

A left exterior wall screen was noted to be broken (Picture 1). Recommend the vent screens to be repaired or replaced to prevent vermins from entering the house.

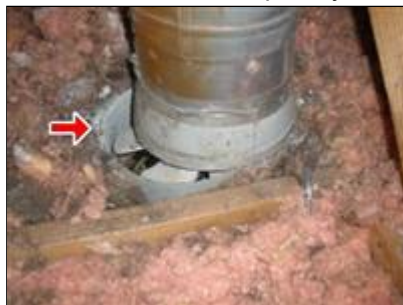
Item 14 - Picture 1

The exhaust vent in the hall bathroom is not properly secured above the ceiling. It leaks exhaust air and moisture into the attic (Picture 1). Recommend further evaluation and repair by a licensed contractor.
